FINAL CLOSEOUT REPORT FOR IHSS GROUP 800-4

UBC 886 - Building 886

IHSS 164.2 - Radioactive Site #2, Building 886 Spill

February 2003

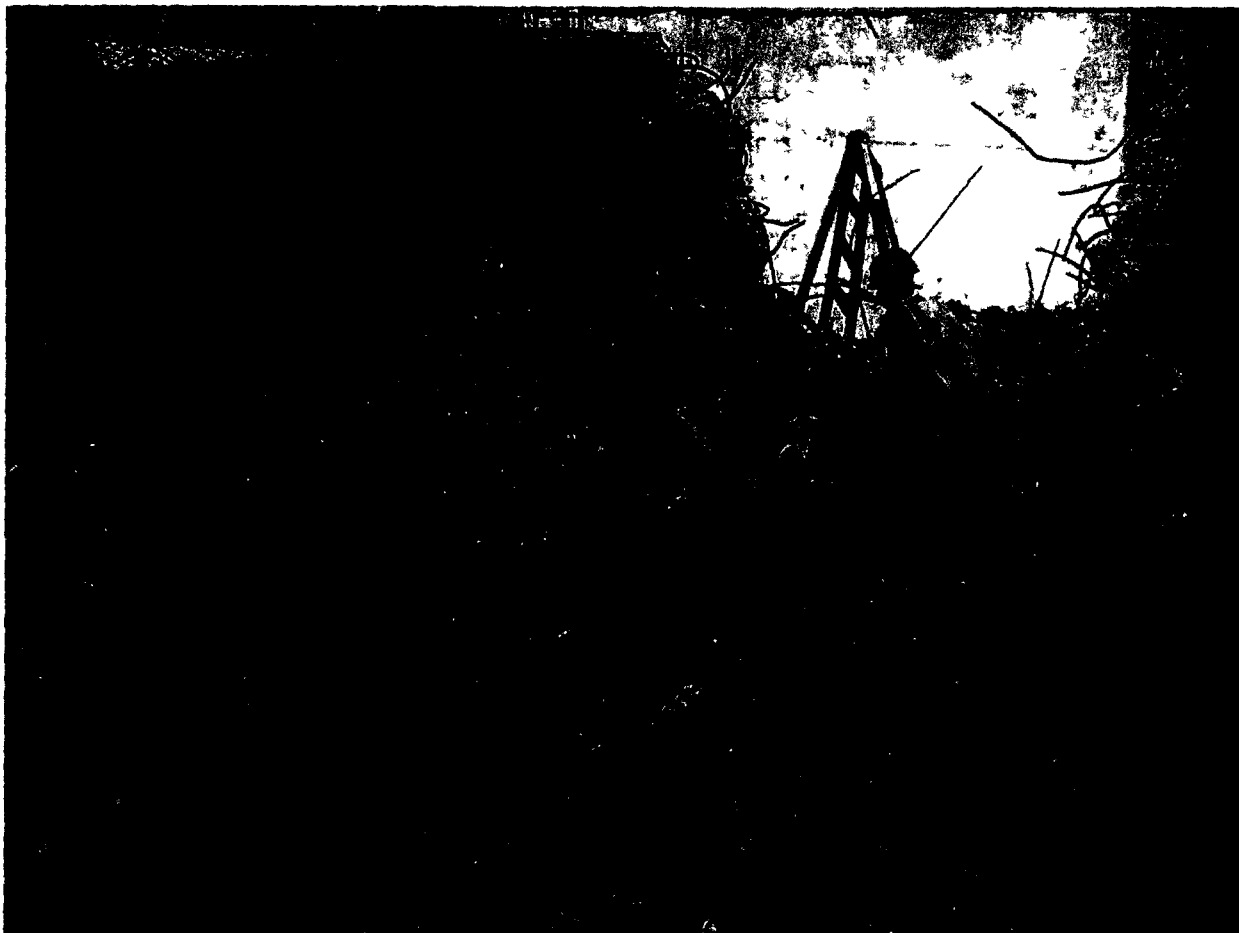
PHOTOGRAPH #5

May 15, 2002 Looking west from Building 886, at the Building 828 Pit Sample crew is flagging locations where characterization samples were taken under the OPWL Both P-63 and P-64 entered the Building 828 Pit

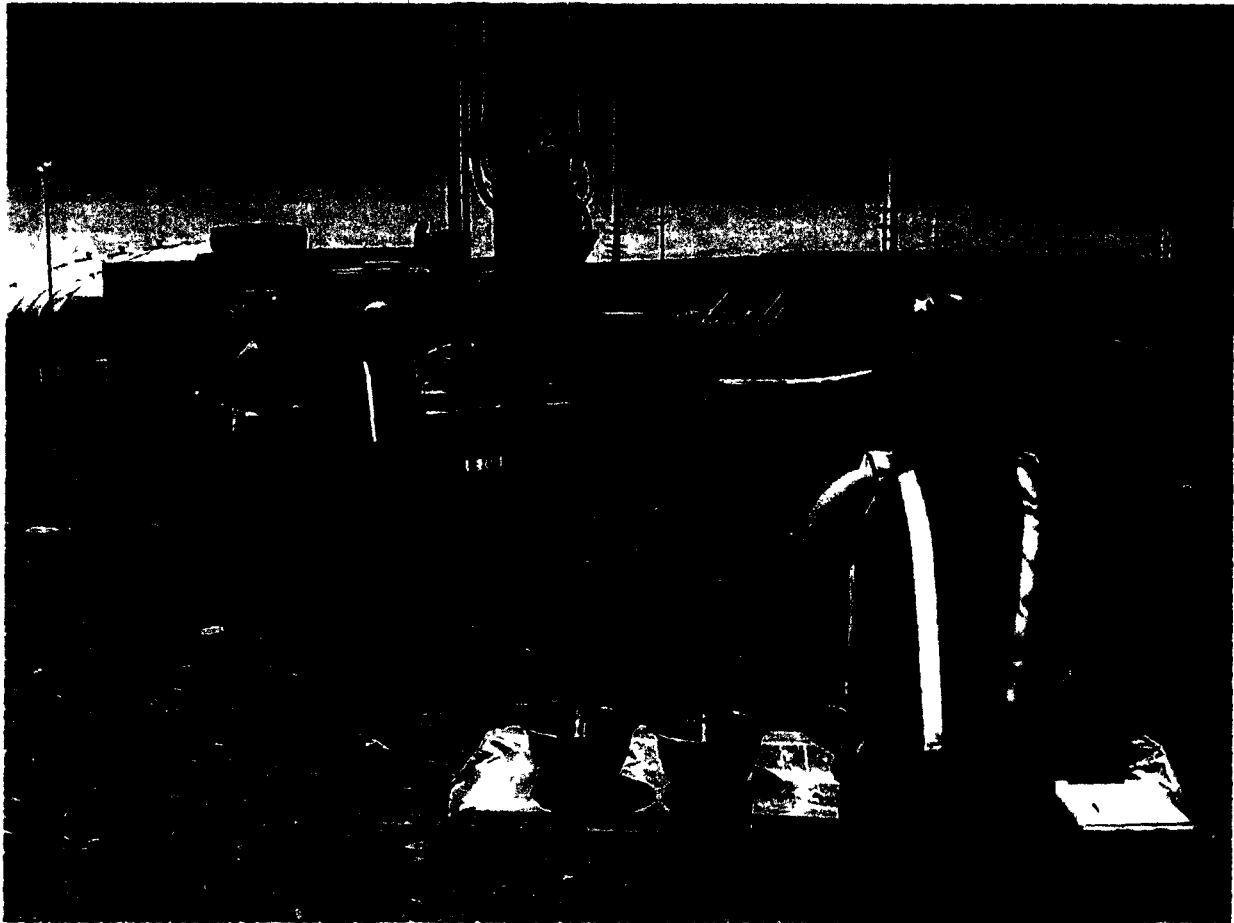
PHOTOGRAPH #7

June 3, 2002 Statistical grid sampling at Building 886 locations after completion of facility demolition activities

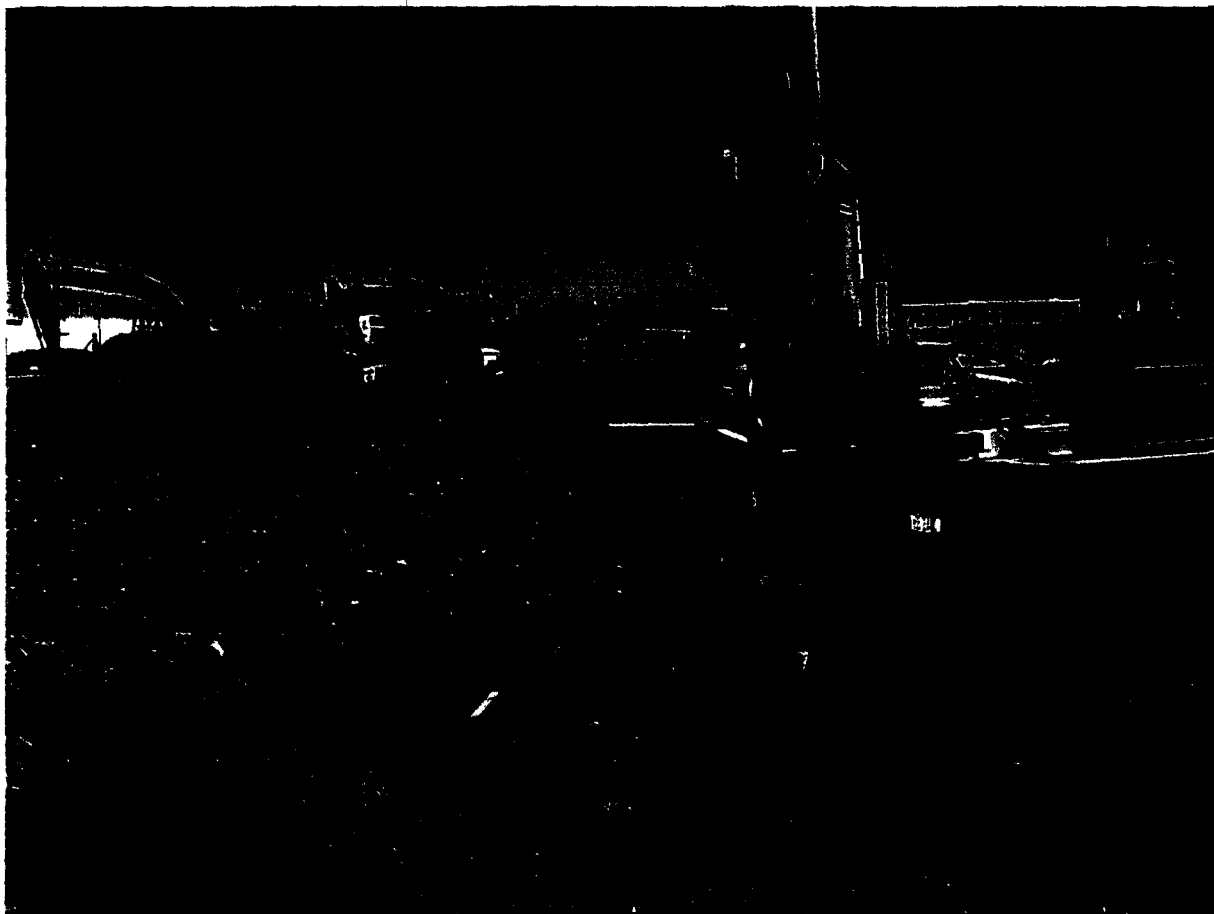
PHOTOGRAPH #8

June 3, 2002 Statistical grid sampling at Building 886 locations after completion of facility demolition activities

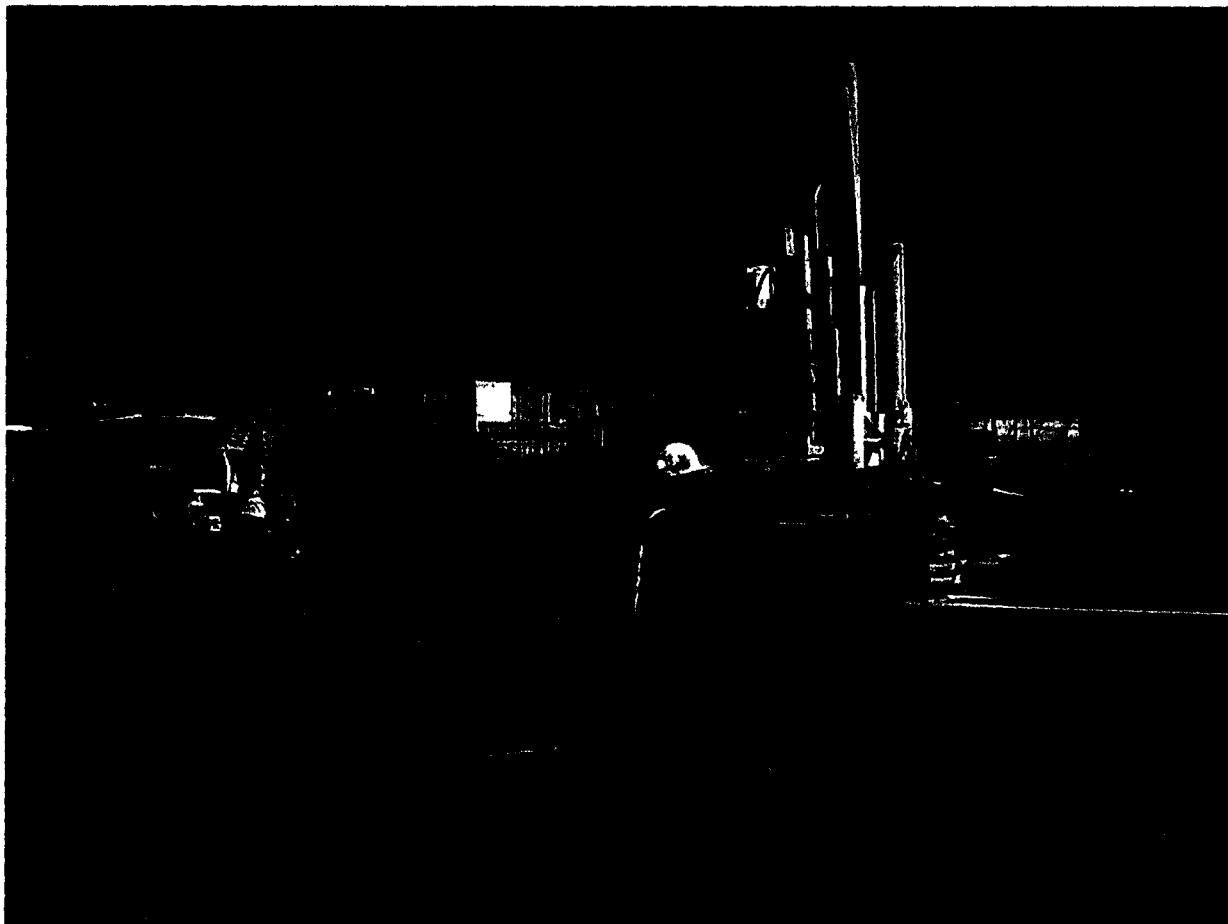
PHOTOGRAPH #9

June 3, 2002 Statistical grid sampling at Building 886 locations after completion of facility demolition activities

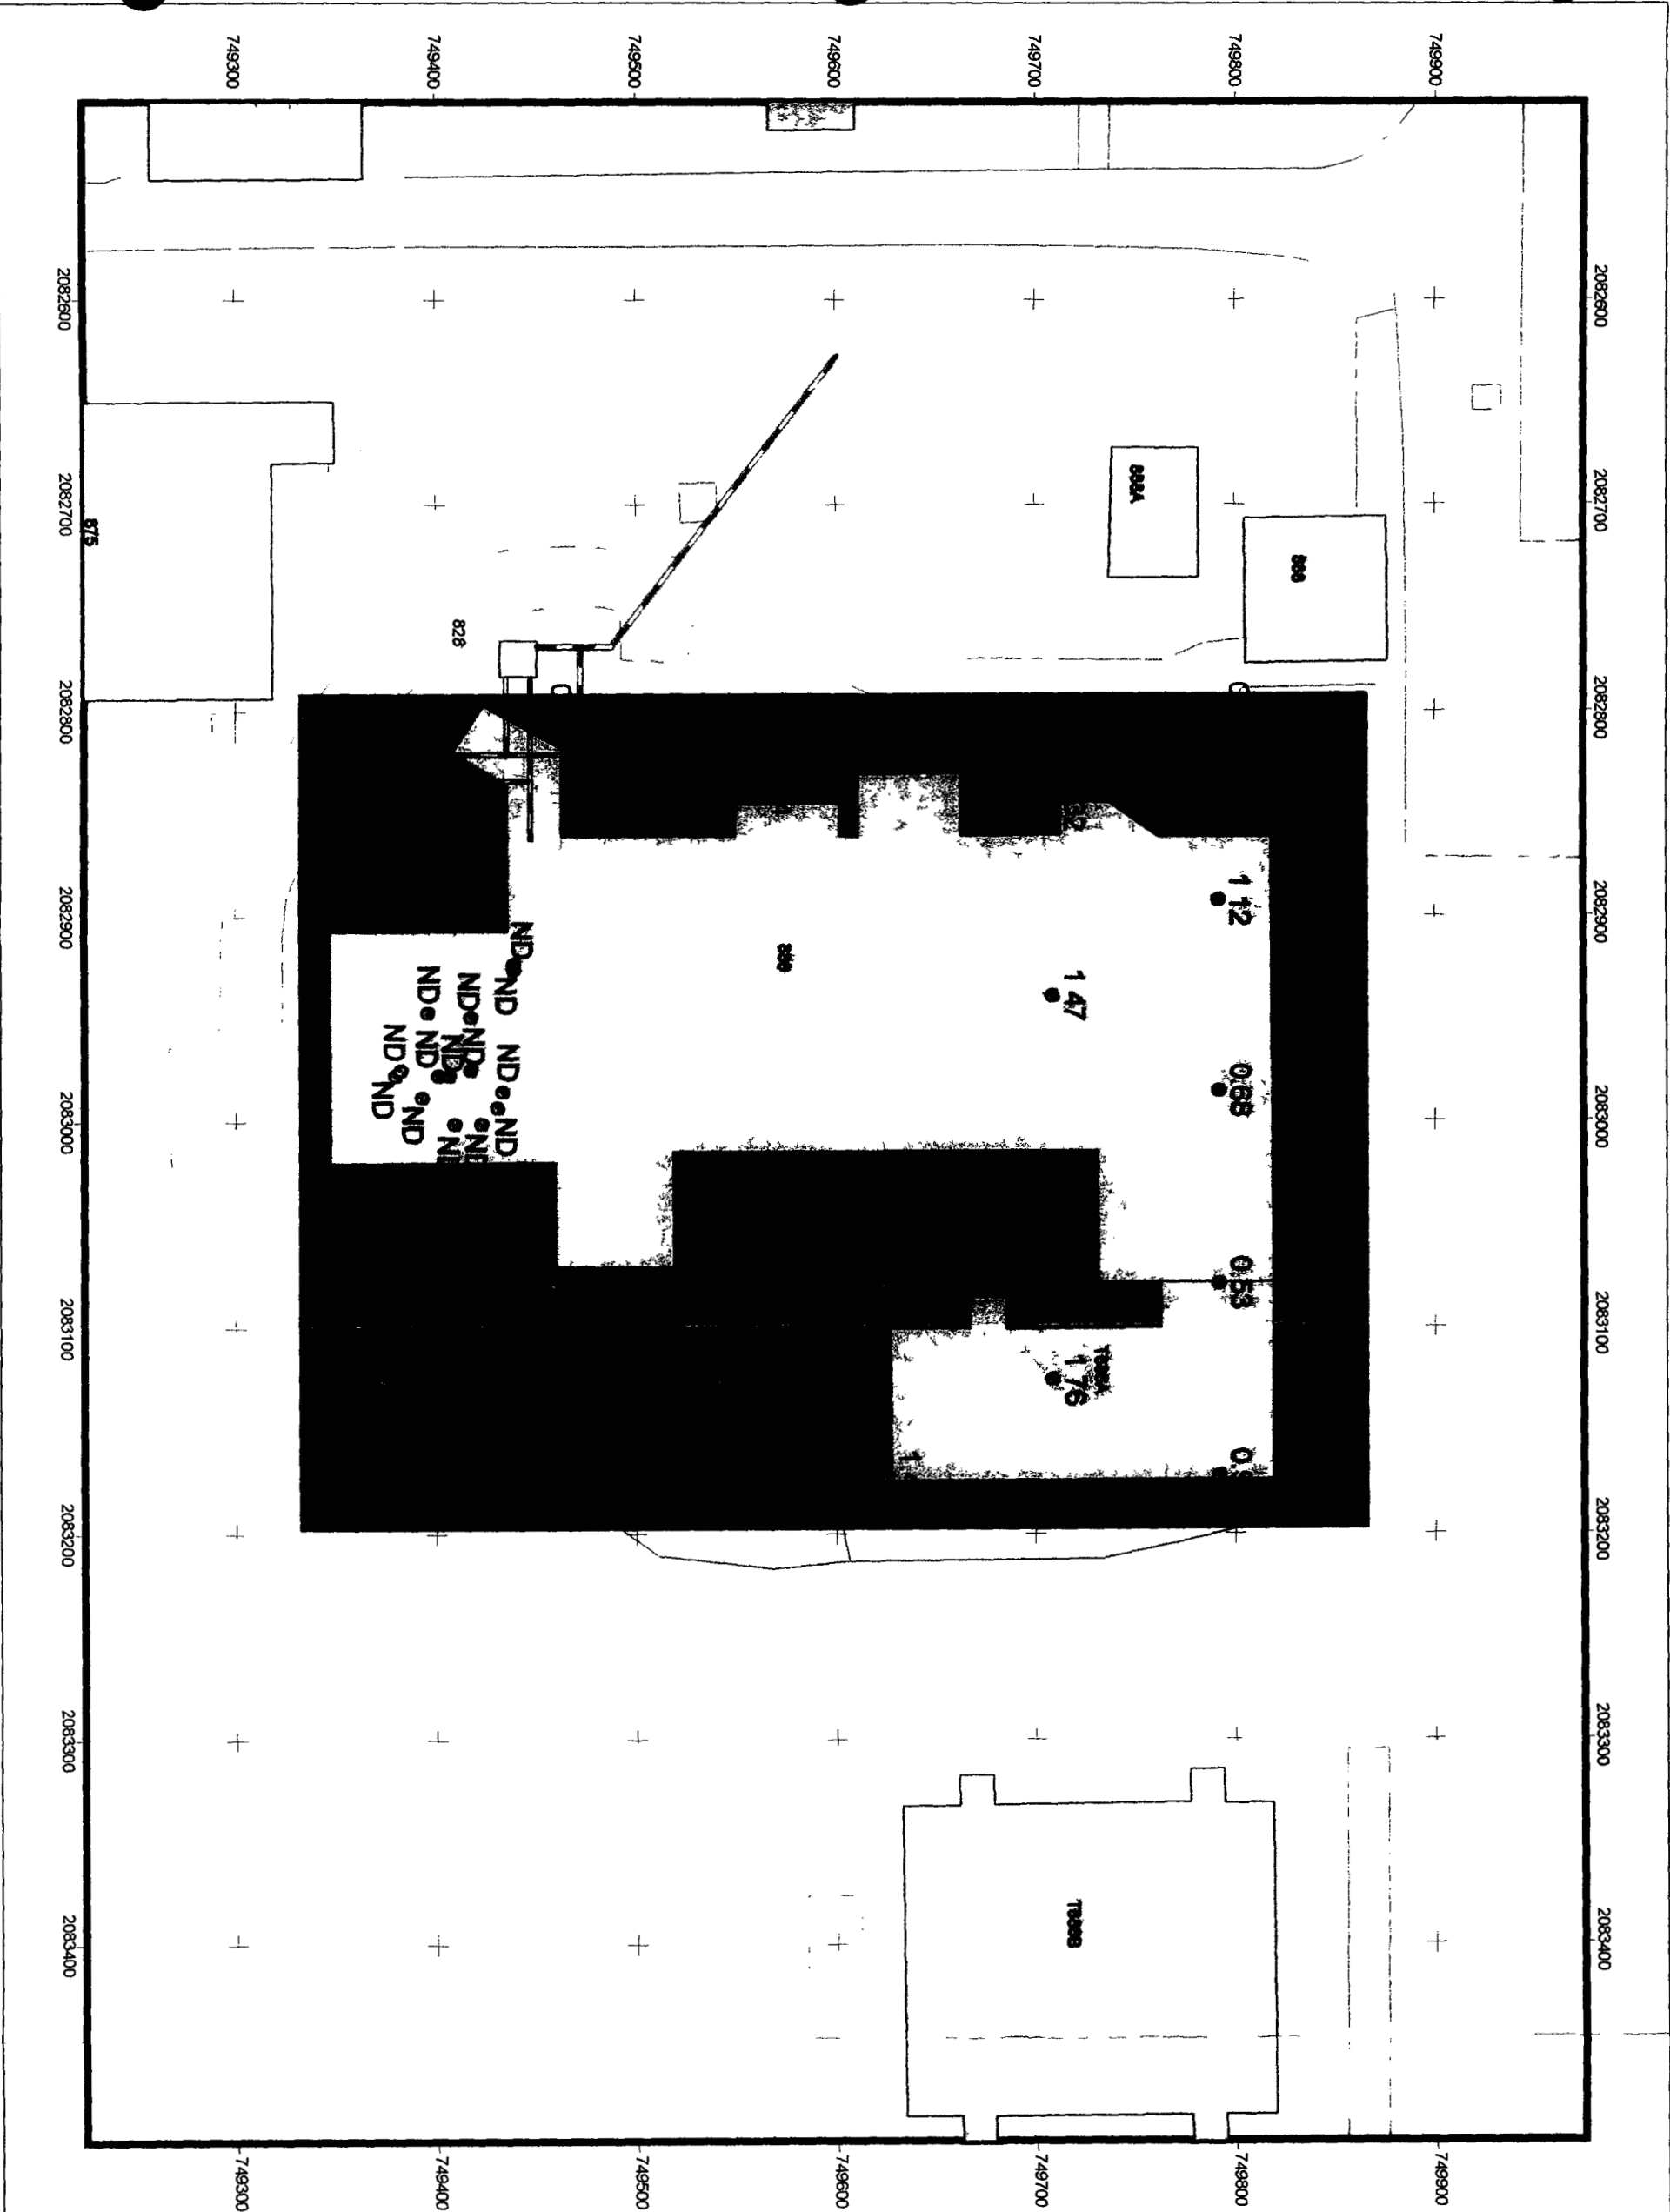
Figure 8d
IHSS Group 800-4 Subsurface
Soil Characterization Samples
RFCA Tier II Sum of Ratios
(Nonradionuclides)

Characterization sample SORs are listed in Table 5 and depicted in Figures 8a through 8d. The Area of Concern (AOC) is shown in Figure 9. Characterization sampling results indicate that all contaminant concentrations are less than RFCA Tier I ALs. Tier II SORs for nonradionuclides exceed the threshold value of 1 at 10 locations in surface soils and 15 locations in subsurface soils. The extent and magnitude of Tier II nonradionuclide exceedances are shown in Figures 8b and 8d. The compounds primarily contributing to the Tier II SOR exceedances are arsenic and
